# Field Implementation and Monitoring of an Ultra-High Performance Concrete Bridge Deck Overlay

Project No. 19CNMS01

Lead University: New Mexico State University

**Final Report**  
**December 2021**

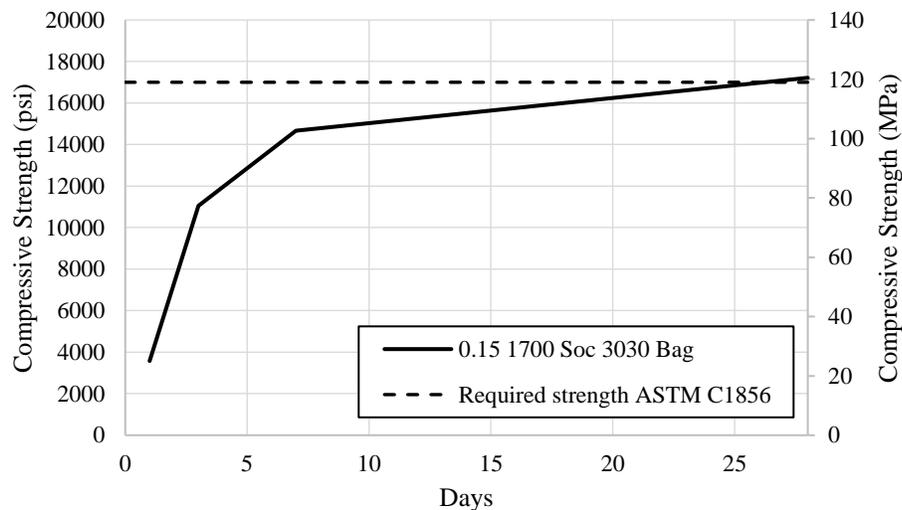
Figure 1. Compressive strength of non-proprietary UHCP developed at NMSU.

UHPC mixtures were proportioned by varying an individual constituent so that its effect on the properties of a mixture could be studied. After investigating the workability and strengths of the mixtures, one mixture was selected as the best candidate for overlay applications that provided adequate workability and met the minimum 28-day compressive strength requirement of 17,000 psi (117.2 MPa) (14). The compressive strength gain curve of this non-proprietary UHPC is shown in Figure 1. This mixture used 0.5 in. (13 mm) steel fibers as shown in Figure 2 to fill 1.5% of the UHPC volume. Tayeh et al. (27) reported that the performance of UHPC greatly depends on the properties of the fiber reinforcement.

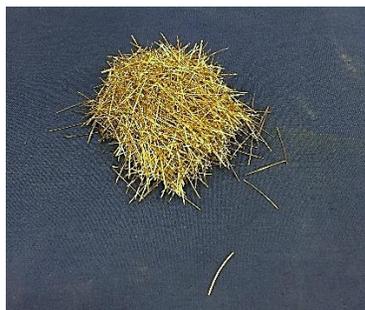
Figure 2. Steel fibers used for UHPC fiber reinforcement.

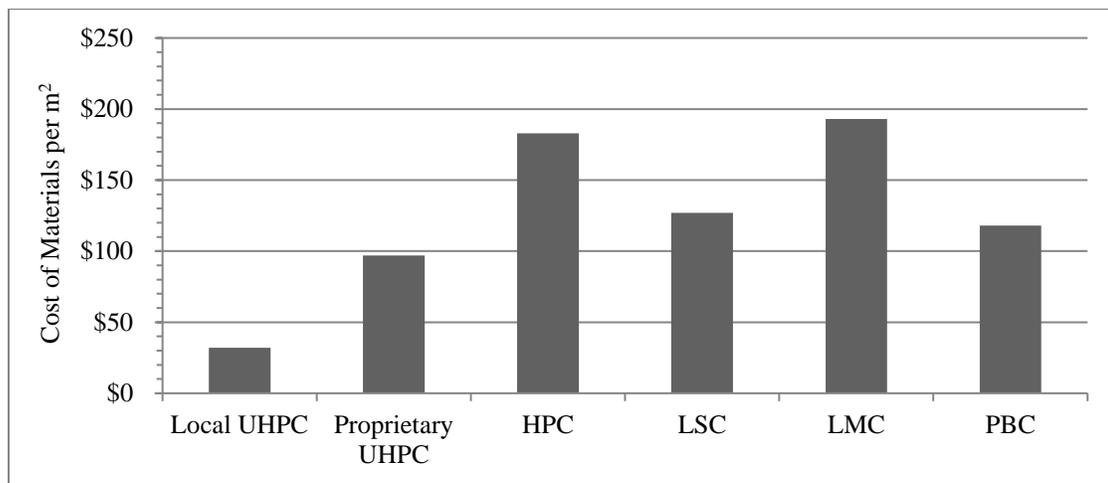
Figure 3. Material cost per m<sup>2</sup> of different overlaying material alternatives (2).

Bridge deck overlays are a common rehabilitation option to extend the life of concrete bridge decks. Common overlay materials include high-performance concrete (HPC), low-slump concrete (LSC), latex-modified concrete (LMC), and polymer-based concrete (PBC). However, each of these alternatives has drawbacks such as cost, service life expectancy, or availability. Figure 3 shows a cost comparison in US dollars of these overlay alternatives. It should be noted that the cost of local UHPC in Figure 3 includes only materials cost while the other alternatives include construction costs (2). Guidelines for selection of bridge deck overlays, sealers, and treatments approximated bridge deck replacement to cost \$43 - \$53 per square foot (\$462-\$570 per square meter) in 2009 (3).

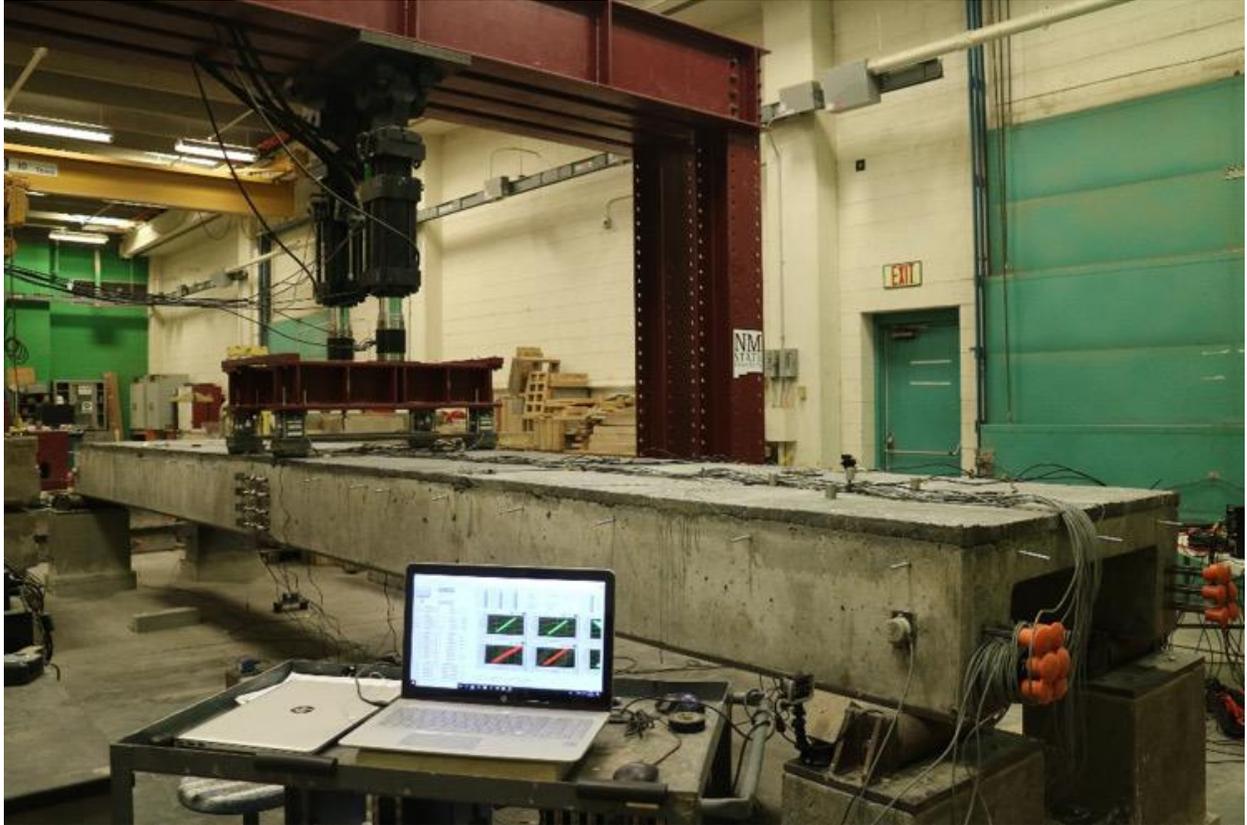
Figure 5. UHPC overlaid girder flexural testing setup (1).

The final major experiment was to overlay a full-scale channel girder to assess the response of a high-performance concrete, pre-stressed bridge girder with a 1 in. (25 mm) UHPC overlay to flexural loading as shown in Figure 5. The girder was subjected to 1000 load-unload cycles to specified service load conditions. Cyclic loading was applied both before and after application of the UHPC overlay to provide a comparison of global behavior and performance of the girder and overlay. Finally, the UHPC overlaid girder was loaded to failure to investigate post-cracking and ultimate behavior of the composite member. Little to no visible distress was

observed in the overlay until loads were applied that were substantially greater than expected under normal service conditions (1).

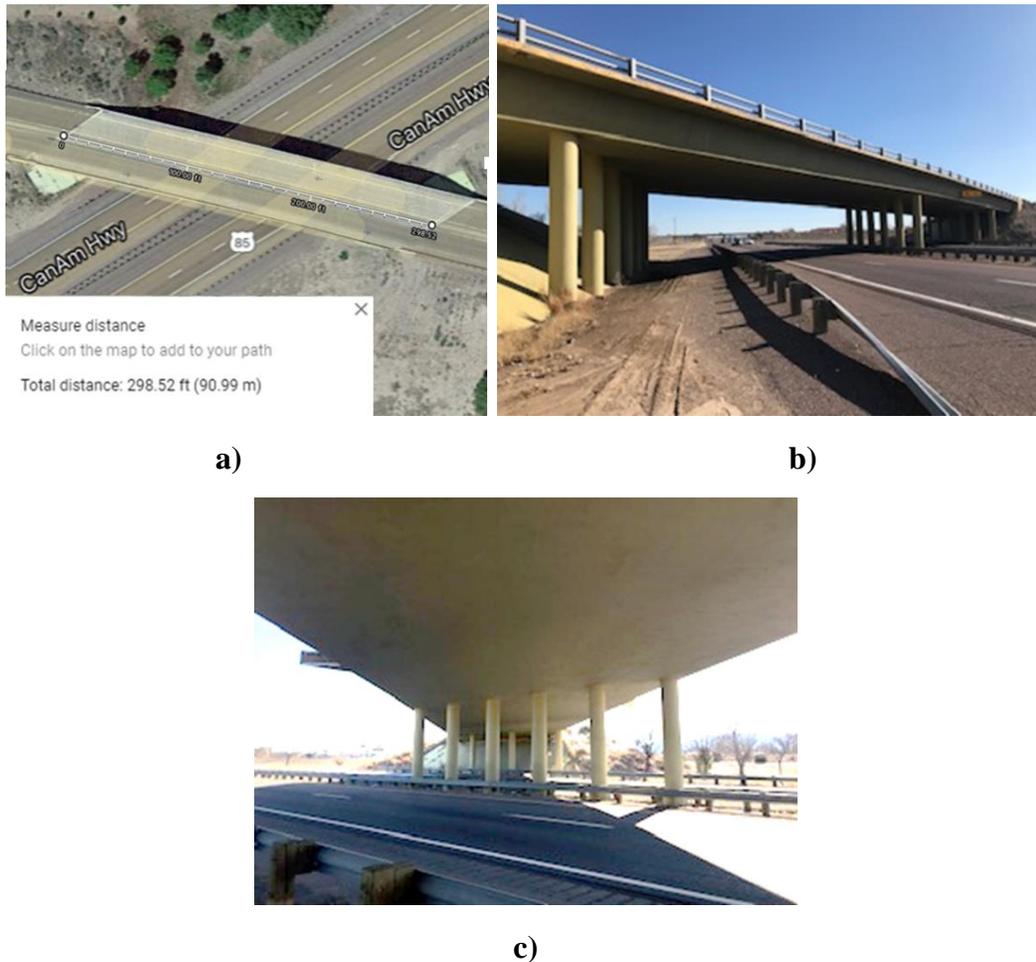
Figure 6. a) Top view of bridge 7032, b) plan view of bridge 7032, and c) bottom of multicell box girder superstructure.

Bridge 7032 off Exit 150 in Socorro, New Mexico is the bridge that was overlaid with a non-proprietary UHPC (Figure 6). The bridge is a two-lane bridge with a center median and is approximately 300 ft. (91.4 m) in length and 54 ft. (16.5 m) in width. This bridge is a four-span, multi-cell box girder bridge with three intermediate supports provided by column bents (integral caps) containing six cylindrical columns as shown in Figure 6. A site visit allowed the researchers to assess what instrumentation would be feasible for this bridge. Because of the box girder superstructure (shown in Figure 6), the underside of the deck could only be accessed by entering the box girders. The bridge is a two-lane bridge with the traffic lanes separated by a small concrete median as shown in Figure 7. The concrete deck has a tined finish to provide skid resistance.

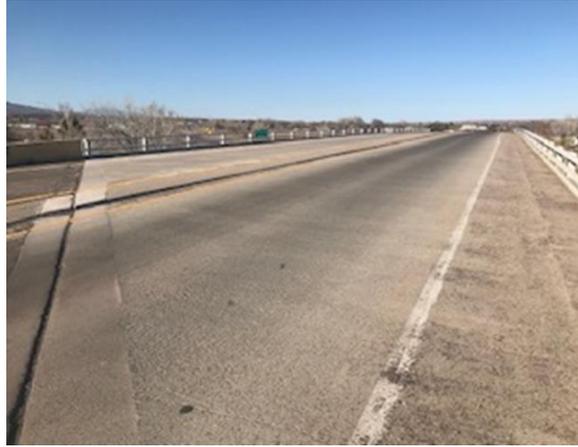
Figure 7. Bridge 7032 concrete deck with two lanes separated by a median.

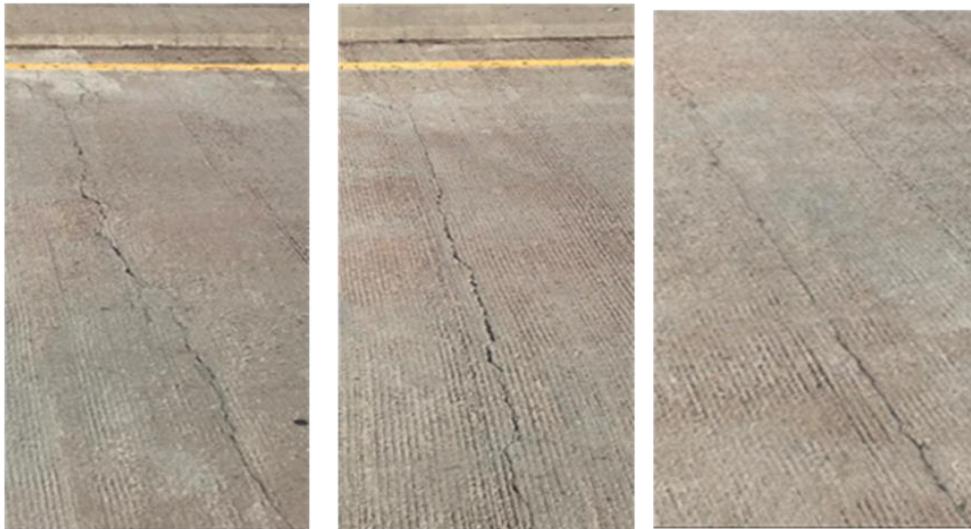
At several locations along the bridge deck there were transverse cracks approximately 1/16 in. (1.59 mm) in width as shown in Figure 8. The transverse cracks were primarily located at the negative moment regions over column bents and potentially full depth. During assessment it was noted that there was no evidence of delamination on the bridge deck.

Figure 8. Transverse cracks observed on the concrete bridge deck.

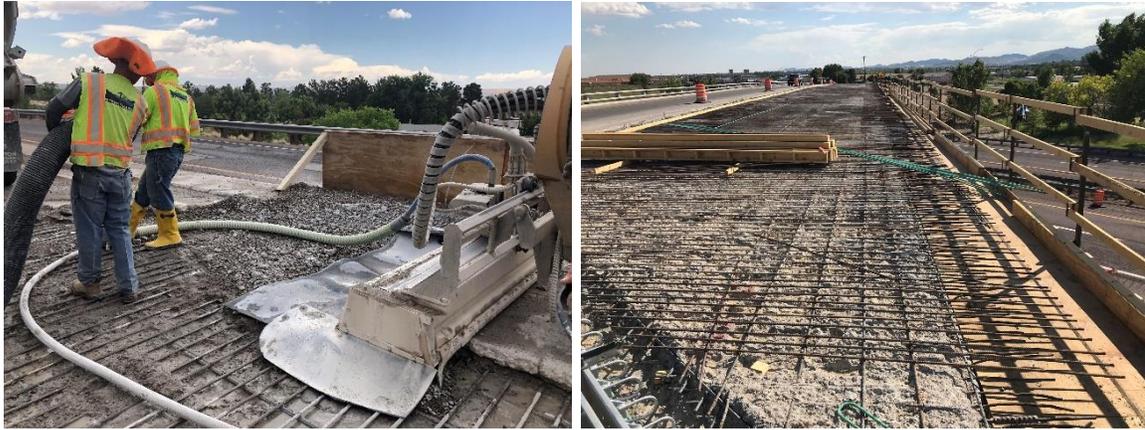
The removal of deteriorated concrete included removing existing metal railing and the deck overhang as shown in Figure 9. Along with the removal of deteriorated concrete, the expansion joint seals were also removed and replaced as shown in Figure 10.

Figure 9. Condition of deck on southbound lane after removal of deteriorated concrete.

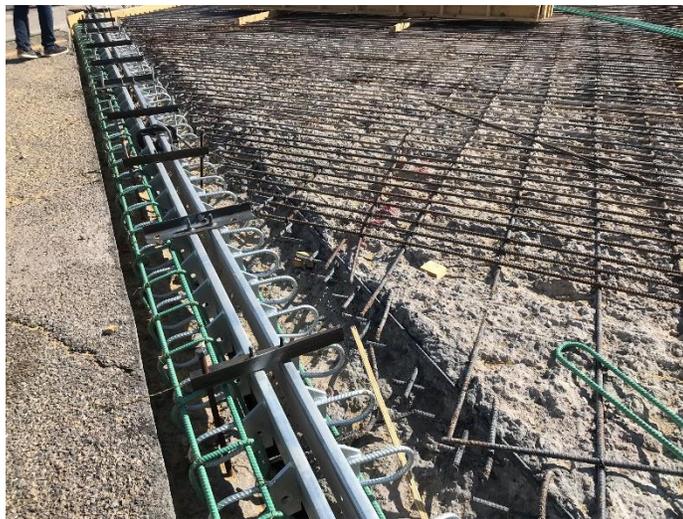
Figure 10. Replacement of the expansion joint seal.

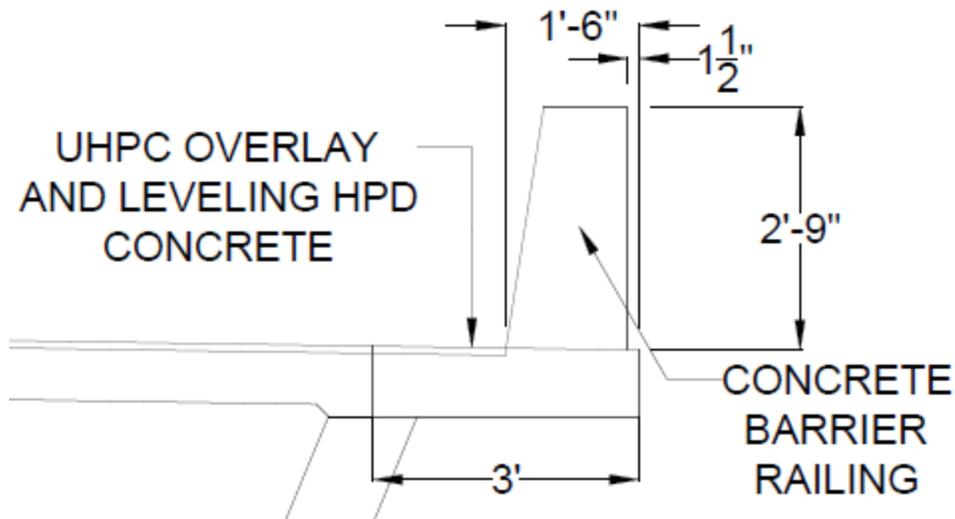
The design for the rehabilitation of the bridge included a 33-inch (838-mm) concrete barrier railing as shown in Figure 11. The raised median was also to be replaced after construction of the 1 inch (25.4 mm) thick UHPC overlay as shown in the illustration presented in Figure 12.

Figure 11. Concrete barrier railing.

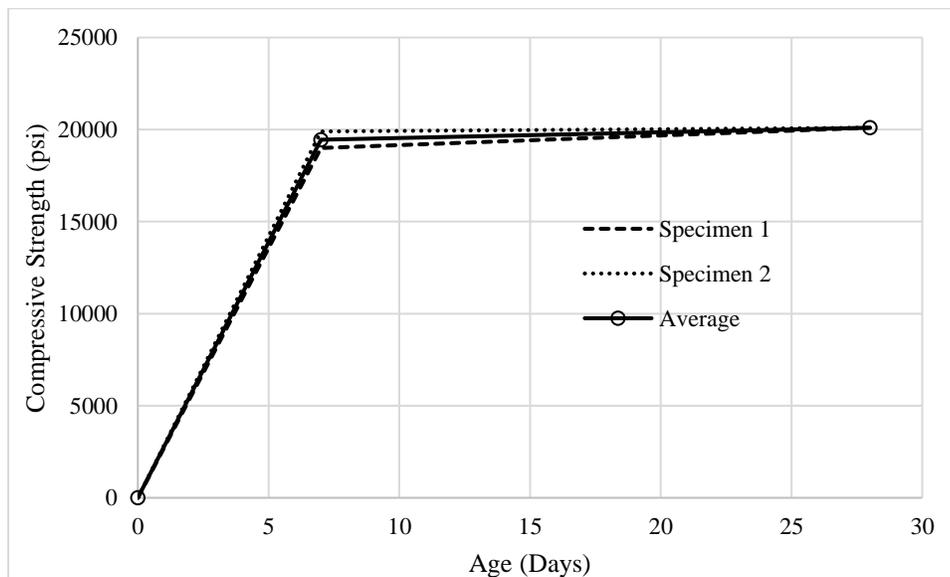
Figure 13. Compressive strength curve of UHPC.

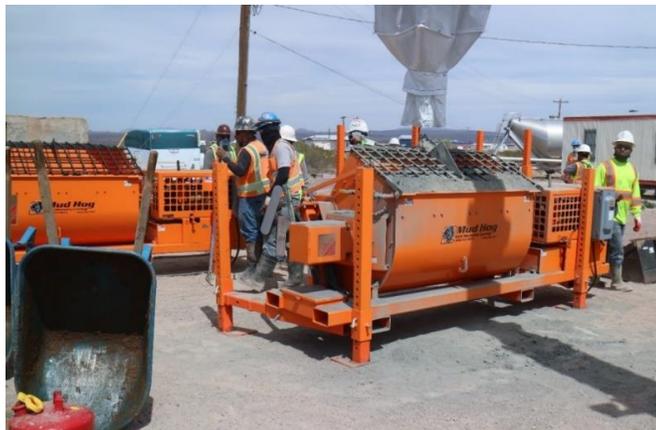
**Figure 14. Horizontal shaft mixers.**

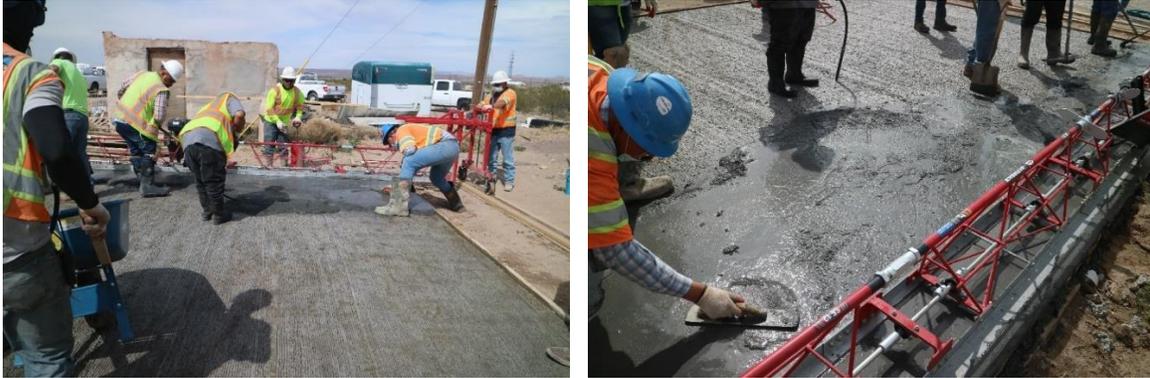
A 0.77 yd<sup>3</sup> (0.59 m<sup>3</sup>) batch volume was selected as the batch size for production placements on bridge 7032. Figure 15 shows the UHPC placement on the HPD slab. During placement, Confilm<sup>®</sup>, an evaporation retardant from BASF was used to reduce surface moisture evaporation against the rapid drying conditions. Figure 16 shows the placement and UHPC finish during mock-up placement 4. The white film on the UHPC overlay, after finishing, is a curing compound applied to the top surface of the overlay.

**Figure 15. Mock-up placement 4 – a) UHPC placement and b) UHPC screeding.**

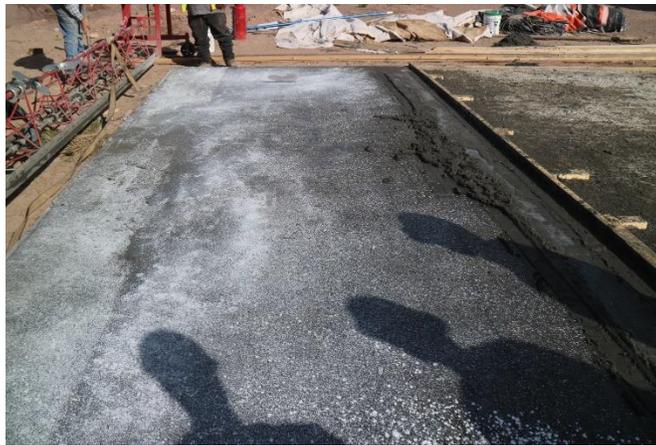
**Figure 16. Mock-up placement 4 – UHPC finish.**

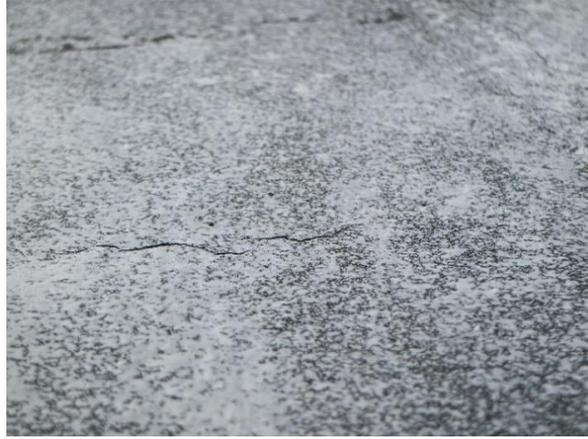
Following the mock-up placement, cracking was observed because the UHPC overlay was not covered with plastic sheeting immediately after screeding and finishing were completed. As a result, cracks were visible within 10 minutes, as shown in Figure 17. Subsequently, the UHPC overlay was covered with a plastic tarp and maintained wet for the following seven days. To assess the integrity of the bond, direct tension pull-off testing was conducted on the overlaid mock-up placement slab. Inadequate pull-off strengths (less than 150 psi [1.0 MPa]) were observed. This can be attributed to improper substrate surface preparation, specifically, the slab was only maintained saturated for one hour prior to overlay placement, and within that hour the surface was lightly sandblasted which caused localized evaporation. However, this mock-up placement was considered successful since the cause of inadequate strengths were known the contractor was allowed to continue with the overlay construction.

Figure 17. Mock-up placement 4 – UHPC overlay cracking.

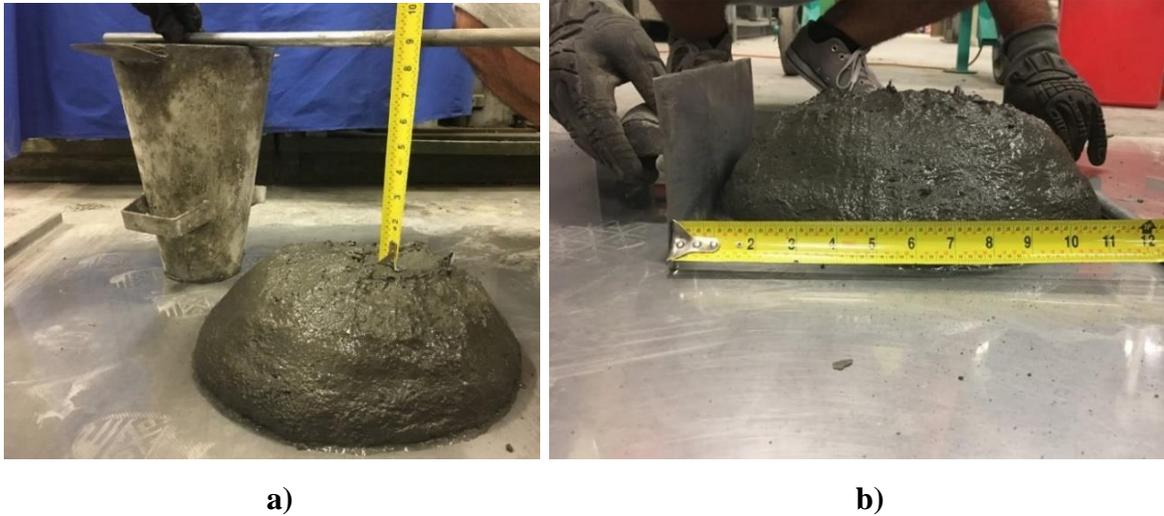
For slump measurements, the cone was inverted, and a steel rod was placed flush with the top of the slump cone. The slump measurement was taken from the center of the top of the UHPC mixture to the bottom of the rod as shown in Figure 18a. The spread was determined by taking average of three measurements across the width of the slumped UHPC as shown in Figure 18b. The target slump and spread measurements were between 8 and 10.5 in. (205 and 265 mm) for slump and between 12 and 19.5 in. (305 and 495 mm) for spread.

Figure 18. a) Slump and b) spread measurements.

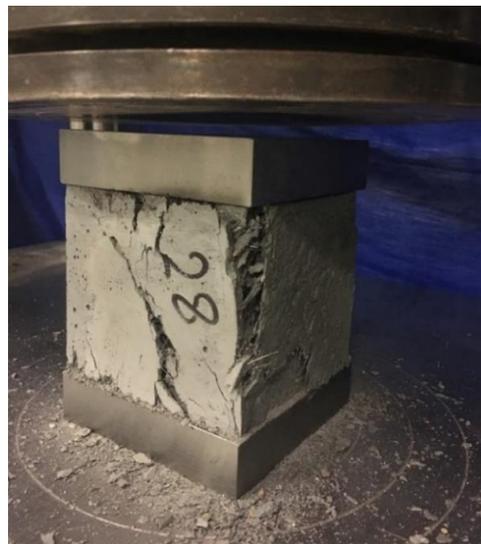
Compressive strength of UHPC was tested in accordance with the British Standard (BS) 1881 (54) at two, four, seven, 14, 28, and 56 days. A minimum of four cube samples were cast for each test day, resulting in a total of 24 samples. Cube specimens used for two, four, and seven-day compressive strengths were cured at ambient conditions (68 °F [20 °C] and 30% relative humidity). Samples for the 14, 28, and 56-day strengths were cured in a moist room (73°F [23°C] and 98% relative humidity). Cube specimens (3.94-in. [100-mm] cubes) from each batch of UHPC were tested at seven and 28 days, for compressive strength. Specimens were loaded to failure, as shown in Figure 19, at a rate of 9000 psi/min (62 MPa/min) following recommendations to accelerate the test (8). The target compressive strengths for the UHPC were 14,000 psi (96.5 MPa) at seven days and 17,000 psi (117.2 MPa) at 28 days. Target strengths were selected by the NMDOT, at seven days, and to meet the minimum strength requirement from ASTM 1856 (14) at 28 days.

Figure 19. UHPC cube sample at failure under compression test.

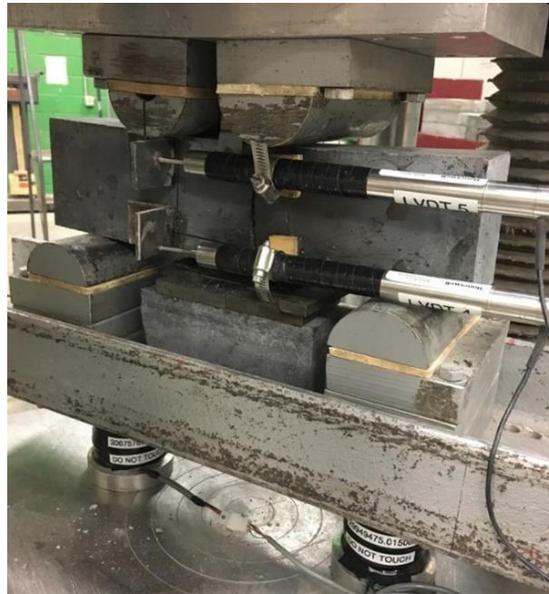
To assess the flexural strength (modulus of rupture [MOR]), testing was conducted according to ASTM C1609 (55) at 7 and 56 days. A minimum of two prismatic samples (3x4x16 in. [76x102x406 mm]) were cast for each test day. Samples used for seven-day flexural strength testing were cured at ambient conditions (68 °F [20 °C] and 30% relative humidity). Samples for 56-day strengths were cured in a moist room (73°F [23°C] and 98% relative humidity). The flexural tests were performed by placing a UHPC prism over a bearing point near each end of the prism, then applying a split load symmetrically about the mid-span location of the specimen. As shown in Figure 20, the four-point flexural tests used linear-variable displacement transducers (LVDTs), load cells, and string potentiometers to monitor the behavior of the specimens. The data obtained from the LVDTs facilitated identification of the first crack load and moment. Then, the first crack load was used to calculate the flexural strength of each prismatic specimen in terms of MOR. The prisms were loaded to failure at a rate of 1500 lbs per minute (6.7 kN per minute).

**Figure 20. UHPC prismatic sample at failure during flexural test.**

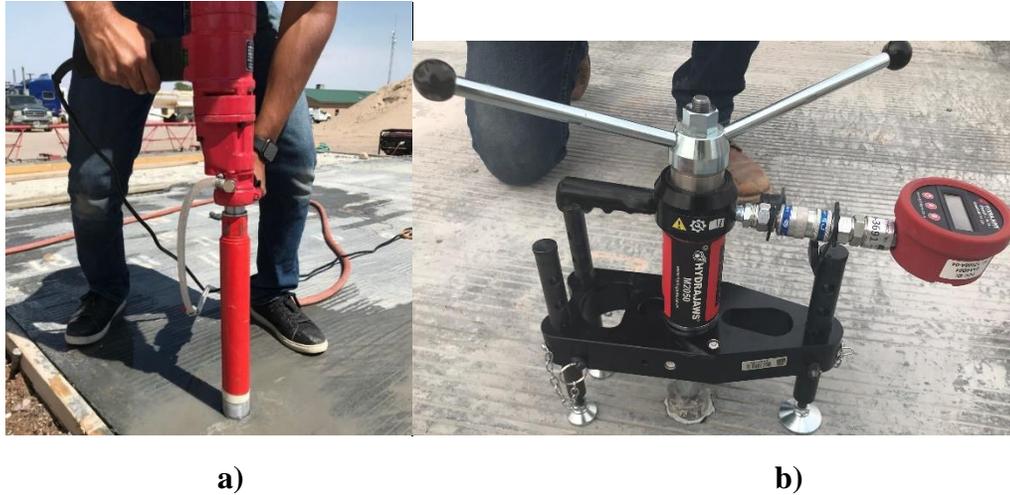
The first step of these tests was to saw 1.875 in. (47.6 mm) diameter cores through the overlay material and approximately 0.5 in. (12.7 mm) into the substrate material as shown in Figure 21a. After completing the coring process the area was dried and debris was removed from the top surface before steel load platens were epoxied to the tops of the cores. The epoxy used to adhere the load platens to the cores (ChemCo Systems Bonder Paste LWL) required 24 hours to cure. After the epoxy had cured for 24 hours, the direct tension tests were conducted using the testing setup shown in Figure 21b.

**Figure 21. a) Core drilling and b) pull-off test setup.**

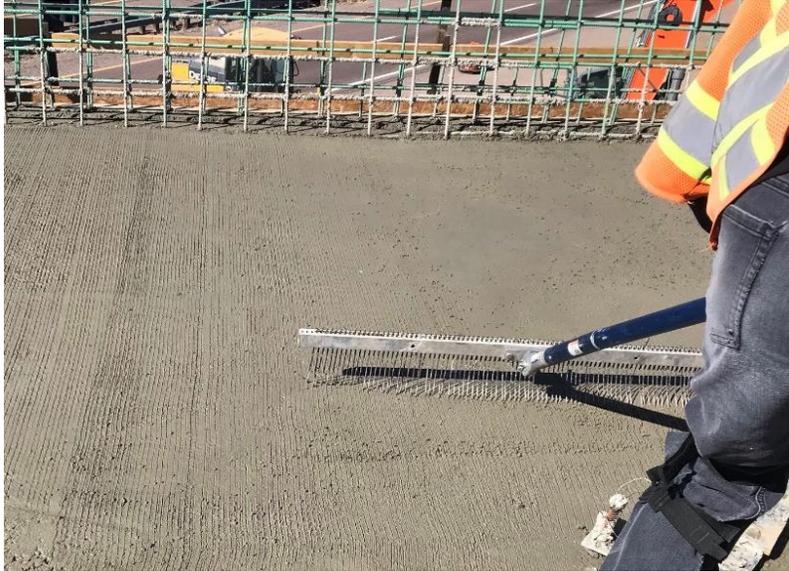
The tined surface appeared to have a texture depth that was at least 0.25 in. (6.35 mm), which is the minimum recommended texture depth for applying repair concrete according to ACI 546 (46).

Figure 24. Tine rake used to texture the HPD surface.

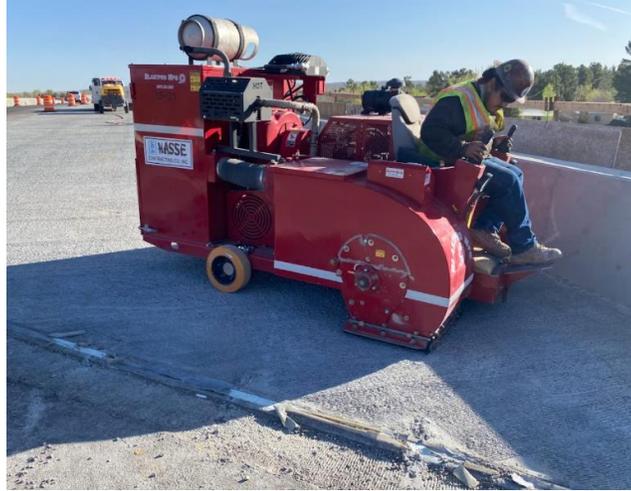
Before placement of the UHPC overlay, the substrate surface was prepared by providing a surface texture and saturated surface conditions. Surface texturing was achieved using the ceramic bead blaster shown in Figure 25.

**Figure 25. Ceramic bead blaster.**

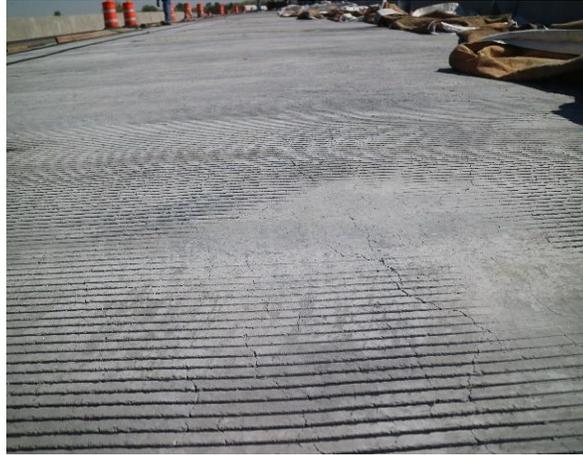
A total of 105 batches were placed on bridge 7032 (53 batches on the eastbound lane and 52 batches on the westbound lane). Production Placements 1 and 2 (eastbound lane) started from the west end of the bridge, and Production Placements 3 and 4 (westbound lane) started from the east end of the bridge. The first placement experienced visible cracking (Figure 26) because the UHPC overlay was not covered under plastic sheets and burlap as soon as surface finishing was completed. Therefore, curing procedures were modified for Production Placements 2 through 4. The revised curing procedures required application of curing compound immediately after screeding and finishing were completed, and then coverage with plastic sheets as soon as possible after the curing compound is applied. The revised curing practices resulted in no significant cracking being observed for the remaining production placements.

Figure 26. Production placement 1 – UHPC overlay cracking.

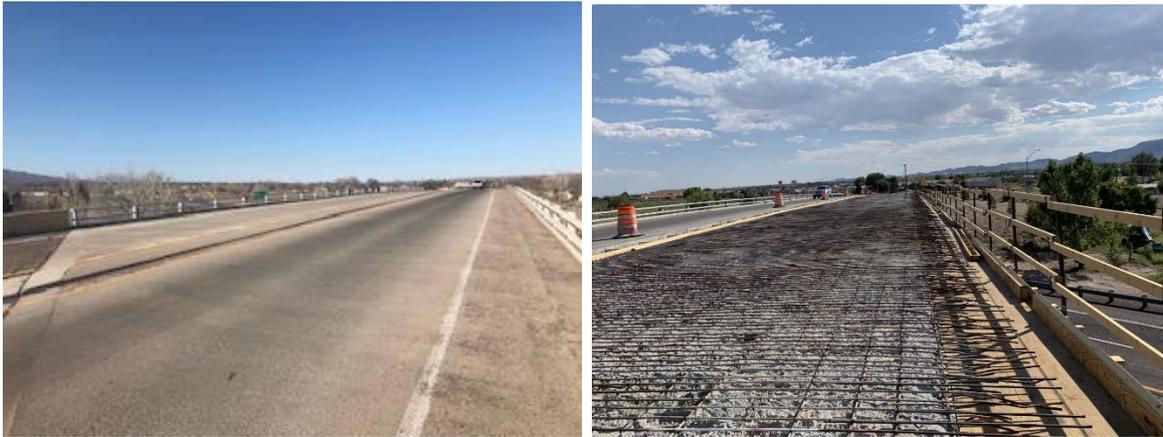
Figure 27. Bridge 7032 before and after first deck section removal.

Preceding the placement of the HPD on bridge 7032, internal and embedded sensors were installed to monitor the structural performance of the bridge superstructure and, eventually, the UHPC overlay. Figure 27 shows bridge 7032 before and after initial deck removal. External sensors were attached to the ceiling inside the cells of the multi-cell box girder superstructure, while embedded sensors were installed inside the HPD. Figure 28 illustrates the external sensors used inside the box girders cells (strain gauges only) and Figure 29 shows the embedded sensors in the deck prior to placement of the concrete (strain gauges and thermocouple). During UHPC placement, embedded sensors were installed inside the UHPC to monitor the overlay behavior. Figure 30 shows the embedded sensors attached to steel bolts resting on the HPD. Sensors were placed inside the overlay material as it was being placed (strain gauges only).

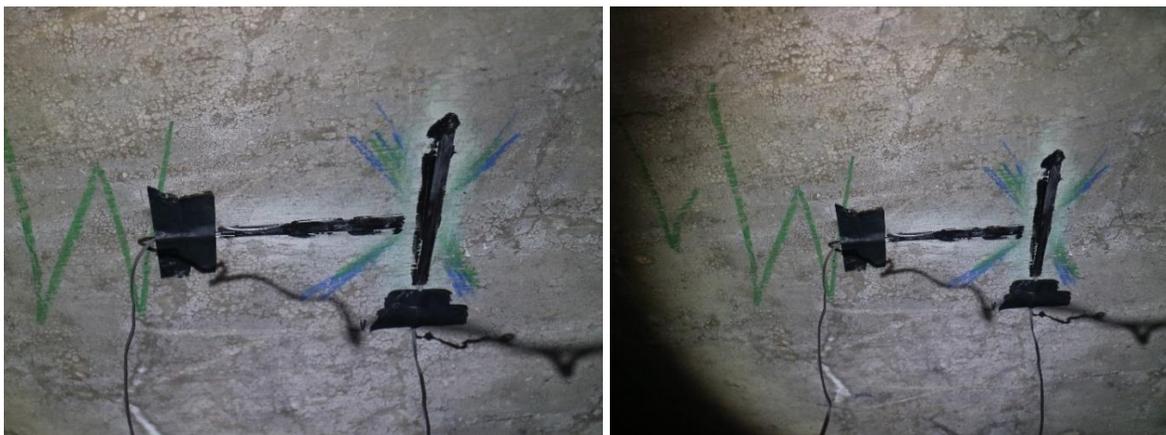
Figure 28. External sensor installation inside box girder cells.

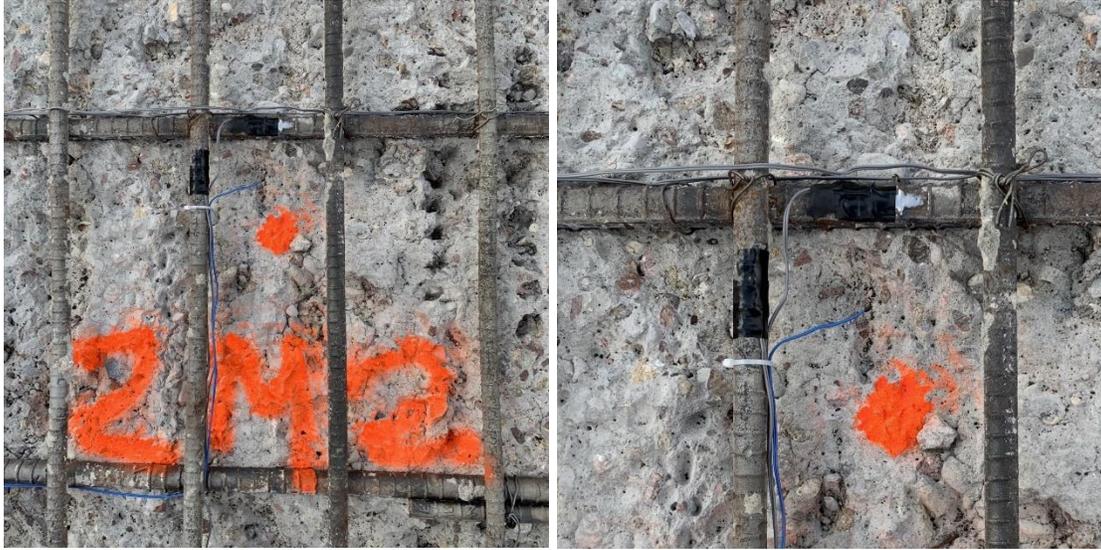
**Figure 29. Embedded sensor installation in HPD.**

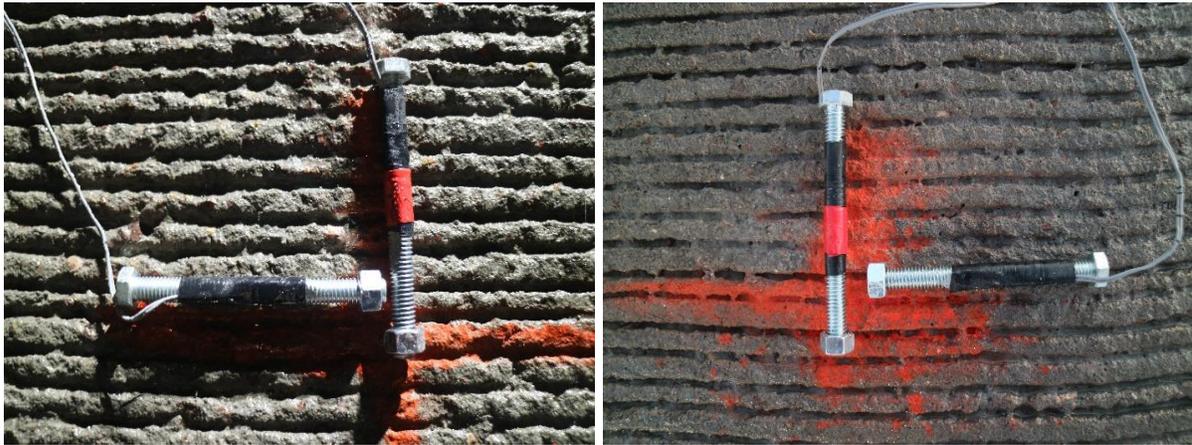
**Figure 30. Embedded sensor installation in UHPC overlay.**

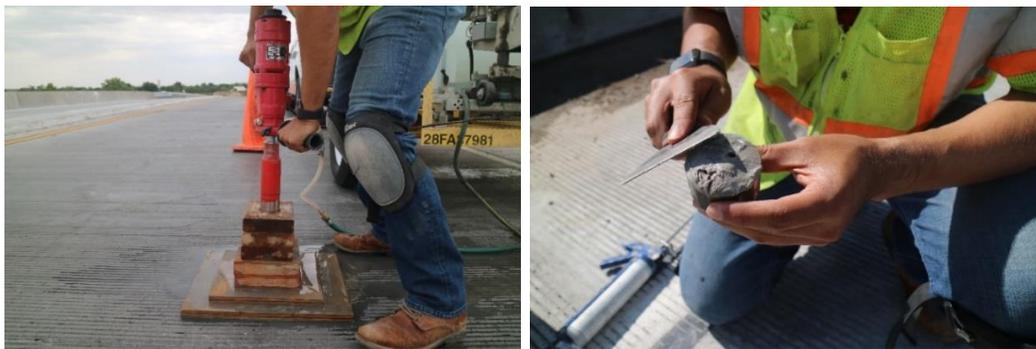
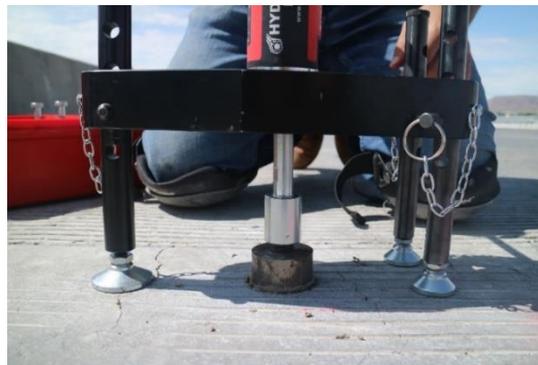
**Figure 36. Direct tension pull-off test on bridge 7032 - a) core sawing, b) epoxying of steel platens, and c) test set up.**

After completing physical testing and NDT to detect locations of potential delamination, direct tension pull-off tests were conducted on bridge 7032. Core drilling, pull-off test setup, and pull-off testing were performed as described in Section 4.6.4 with the only difference being the use of a different epoxy. ASF-GEL from E-Chem, a two-component, fast-cure, epoxy acrylate adhesive gel was used to accelerate curing. Table 3 shows the minimum cure times, based on the temperature of the substrate, used when epoxying the steel platens on the core samples. Direct tension pull-off tests were performed after 20-30 minutes of ambient curing as recommended by the technical data sheet. Figure 36 presents the pull-off testing procedure on

the bridge which was to first core saw (Figure 36a), epoxy steel platens to tops of cores (Figure 36b), then perform test as shown in Figure 36c.

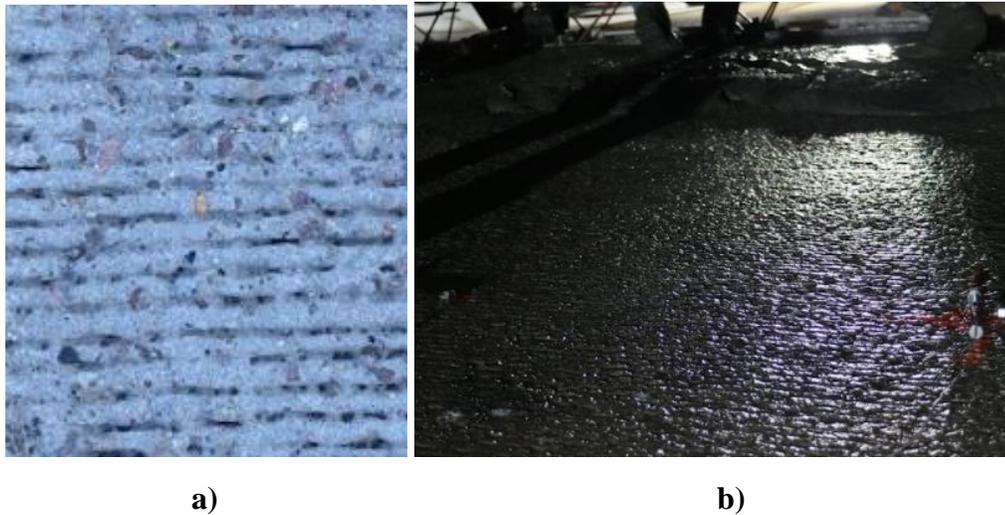
The substrate (HPD leveling course) surface had been finished to provide a tined texture. Prior to overlay placement, it was ceramic bead blasted to remove surface paste. This texturing method was able to partially expose fine aggregate as shown in Figure 37a. After the surface was textured, the deck was thoroughly cleaned of any debris and the deck was maintained saturated for 24 hours prior to UHPC overlay placement. The deck appeared moist at installation of the UHPC overlay, as shown in Figure 37b.

**Figure 37. a) Substrate surface texture and b) substrate surface moisture condition during placement.**

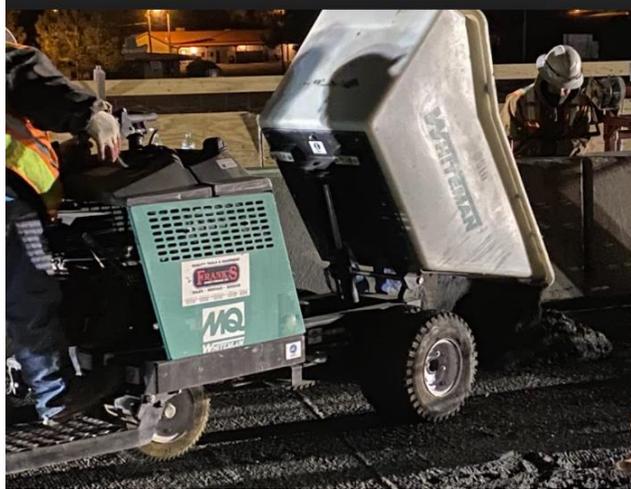
**Figure 38. Concrete buggy delivering UHPC.**

Concrete buggies, shown in Figure 38, with a 16 ft<sup>3</sup> (0.45 m<sup>3</sup>) capacity were used to transport the UHPC from the mixers to the location of placement. Then, construction workers used shovels to spread the UHPC, as shown in Figure 39, in front of a vibrating screed.

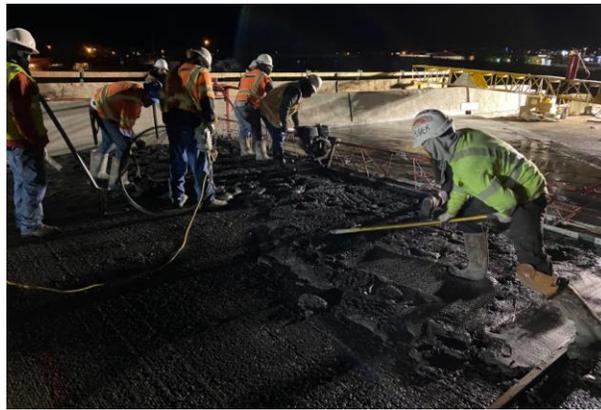
**Figure 39. Construction workers spreading UHPC with shovels prior to screeding.**

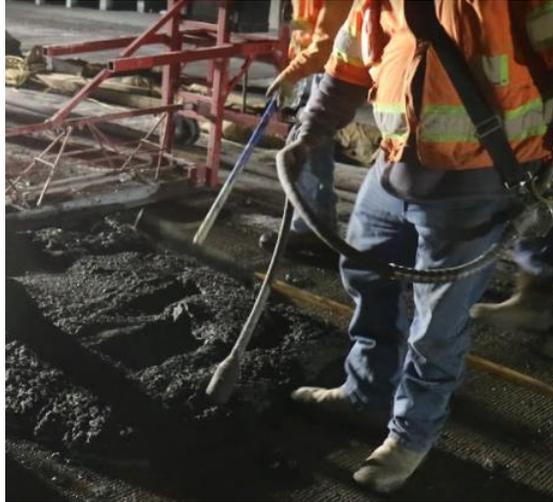
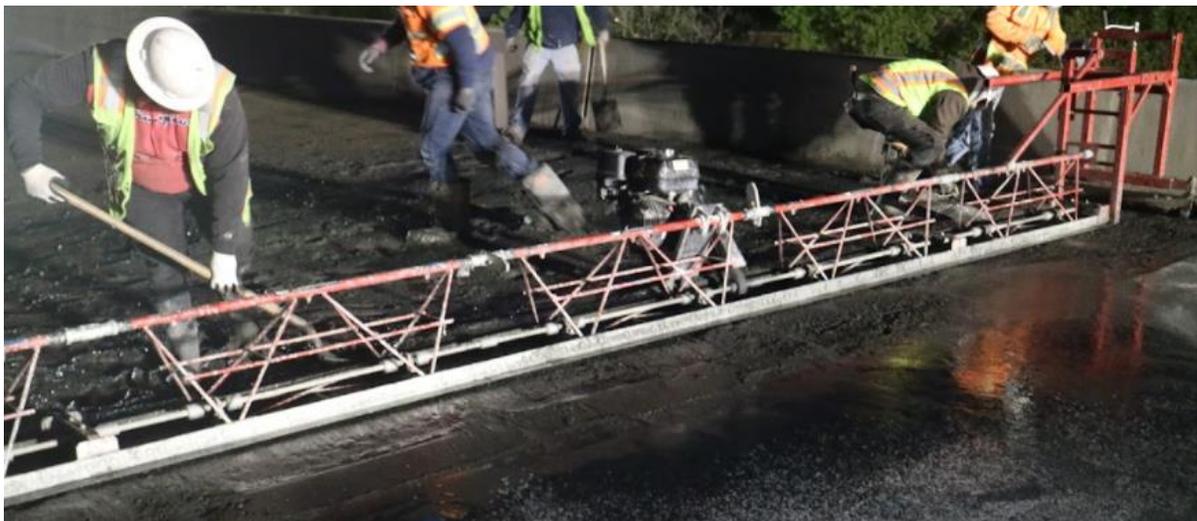
**Figure 40. a) Handheld concrete vibrator and b) vibrating screed.**

The overlay material was consolidated using a combination of concrete vibrating tools. After initial placement, a handheld concrete vibrator was used as shown in Figure 40a. Then, the vibrating screed shown in Figure 40b was used to finish the UHPC overlay and control thickness.

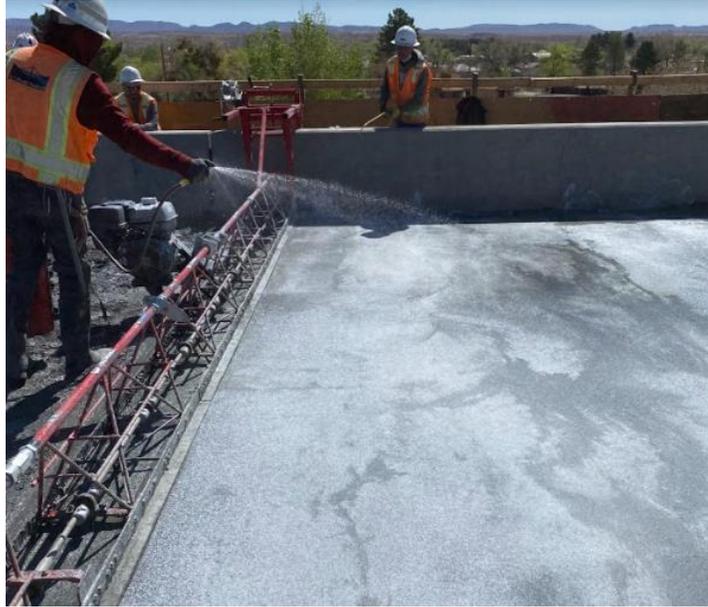
**Figure 41. Application of curing compound after screeding.**

After screeding, curing compound was applied as soon as possible to the finished overlay surface as shown in Figure 41. Then, within only a few minutes after application of the curing compound, the UHPC overlay was covered with plastic sheeting as shown in Figure 42.

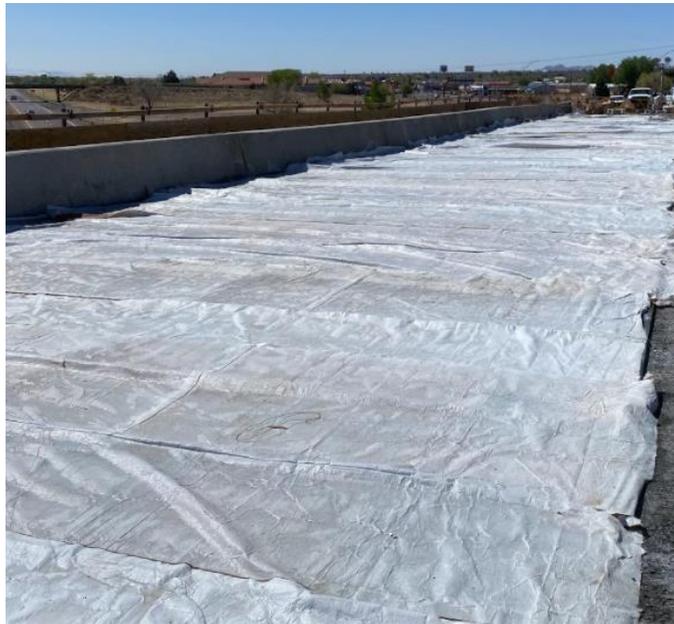
**Figure 42. UHPC overlay covered with plastic sheeting.**

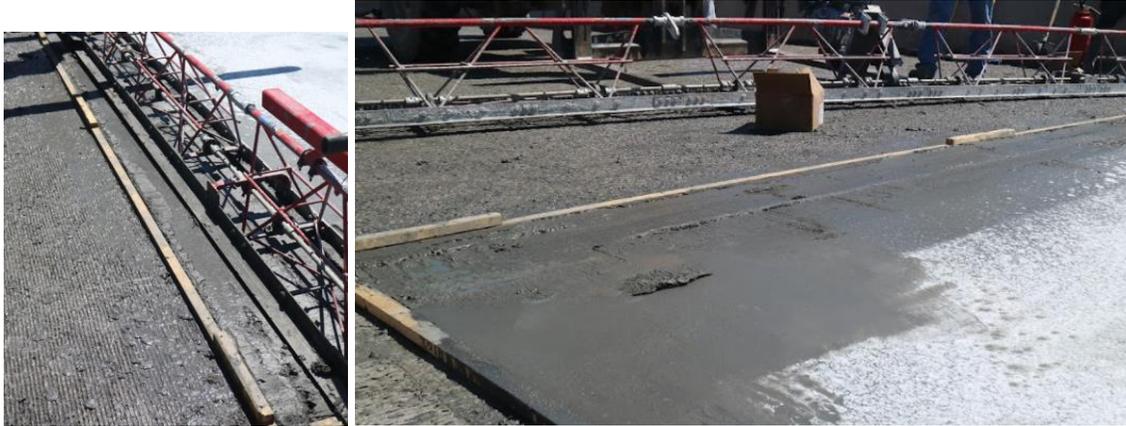
Figure 43. Images of construction joint blocking.

When overlay construction was halted, construction joints were installed as shown in Figure 43. These joints were formed in positive moment regions and were formed using blocking (shown in Figure 43) that provided a 90-degree cold joint. The first construction joint was formed on the eastbound lane, 68.42 ft (20.9 m) from the east end of the bridge, and the second was on the westbound lane, 122.17 ft (37.2 m) from the east end of the bridge.

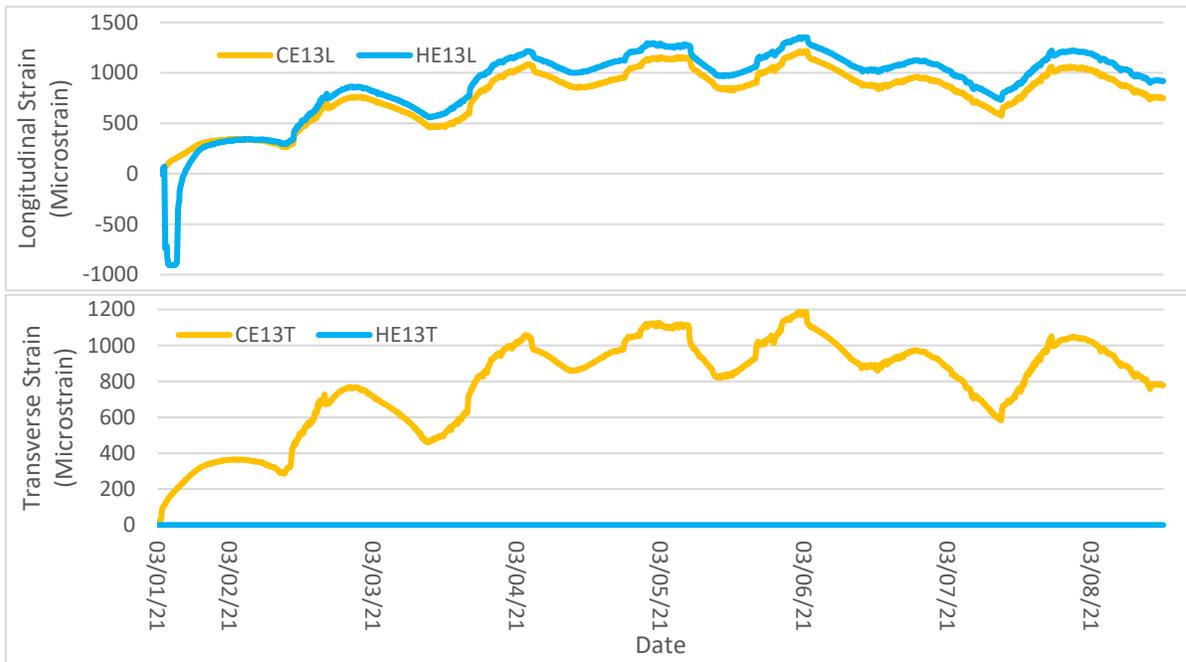
In all three bays, sensors located in the HPD show changes in strain and temperature caused by the eastbound HPD placement. The overall temperatures from eastbound HPD placement were greater than westbound HPD placement because the first placement occurred during a colder weather in December. As with the westbound HPD placement, the daily temperature cycle is easily observed in the strain results, and relative strain changes for sensors in the HPD and box girder cells provide the combined effects of HPD shrinkage and thermal effects in both the HPD and original superstructure concrete. These results are also being used in a detailed analysis on the bridge behavior as part of the NMDOT research project that continues for another two years.

**Figure 60. Longitudinal and transverse strain during HPD placement 1 (eastbound lane) – bay 1 – position 3.**

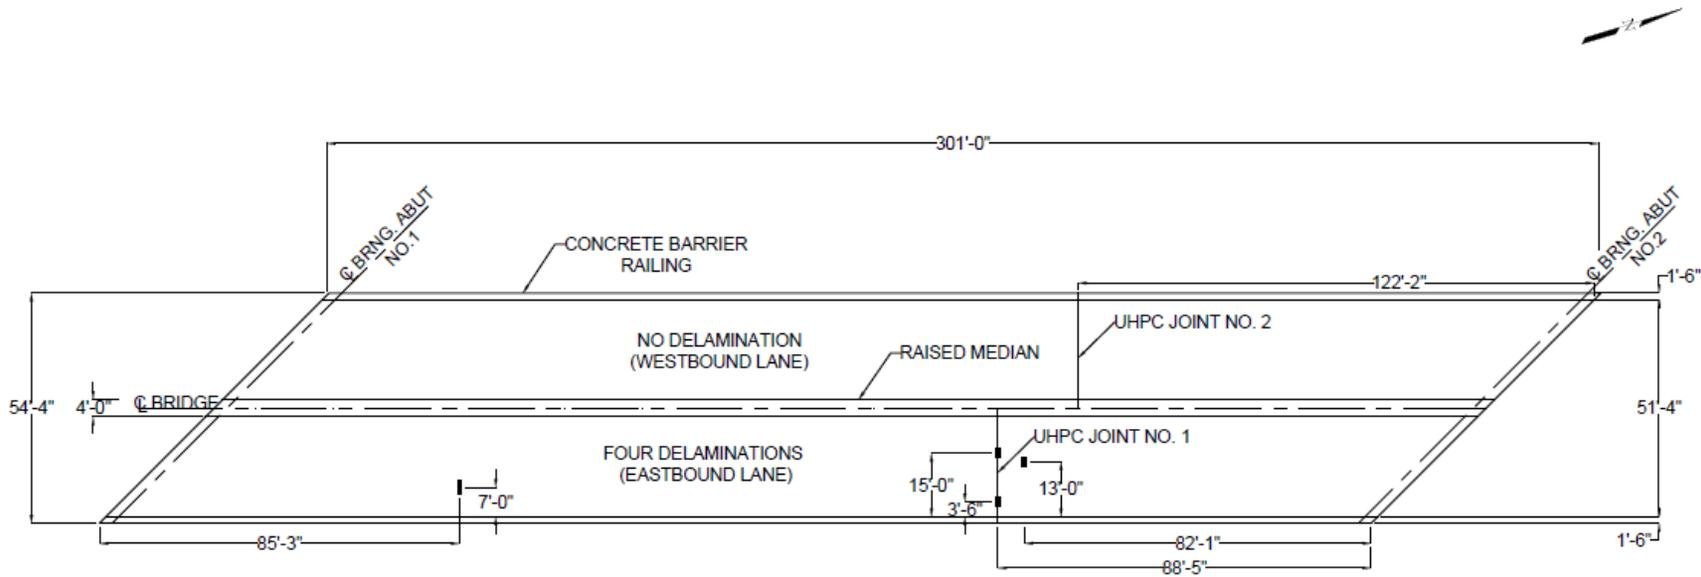
approximately 3.5 ft. by 1 ft. (1.1 m. by 0.3 m.) located 85.25 ft. (25.98 m.) from the east end of the bridge, in the area overlaid during Production Placement 1. Two delaminated areas were identified (both approximately 2 ft. by 1 ft. [0.6 m. by 0.3 m.]) at the joint where Production Placement 1 concluded and Production Placement 2 began. The last potential delamination was approximately 2 ft. by 1 ft. (0.6 m. by 0.3 m.) found 82.08 ft. (25.02 m.) from the west end of the bridge, in the area overlaid during Production Placement 2. Pull-off testing was conducted on the potentially delaminated areas as well as at intact locations.

Figure 72. Delaminated areas on bridge after UHPC placement.
