# Field Implementation and Monitoring of an Ultra-High Performance Concrete Bridge Deck Overlay

Project No. 19CNMS01

Lead University: New Mexico State University

**Final Report**  
**December 2021**

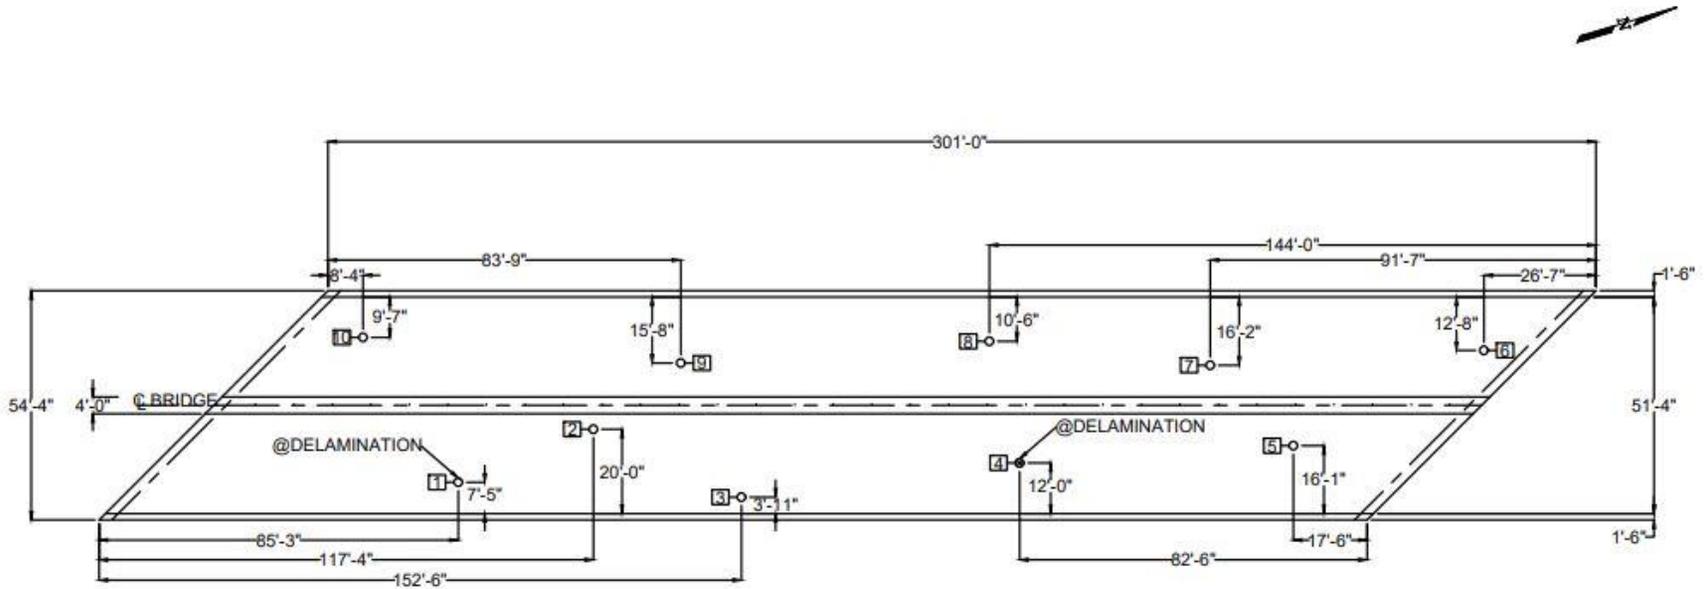
Figure 75. Direct tension pull-off test locations on bridge 7032.

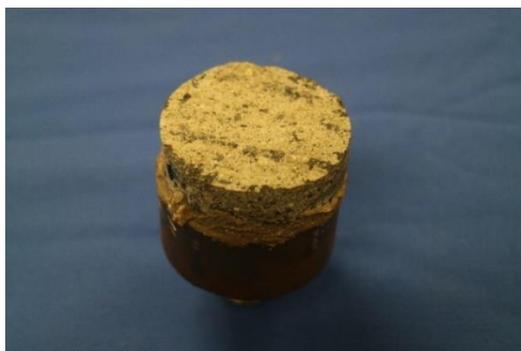
Figure 76. Core sample with substrate that lacks roughness.

Table 8 presents pull-off tensile strengths obtained from 10 locations described in Figure 75. The only zero-strength location was at the fourth suspected delamination. The average bond strength of the nine intact core samples was 239 psi (1.65 MPa), which is slightly less than the recommended tensile bond strength of 250 psi (1.72 MPa) as stated by ACI 546 (2014). However, it should be recognized that four of the tests had failures that occurred at the epoxy, which provides a conservative measurement of the overlay bond strength. Additionally, a low bond strength was obtained for core sample no. 6 that occurred at a location where the concrete substrate surface was not rough, as shown in Figure 76. Figure 77 shows the UHPC/Epoxy type of failure for core samples no. 3, 7, 9, and 10, respectively.

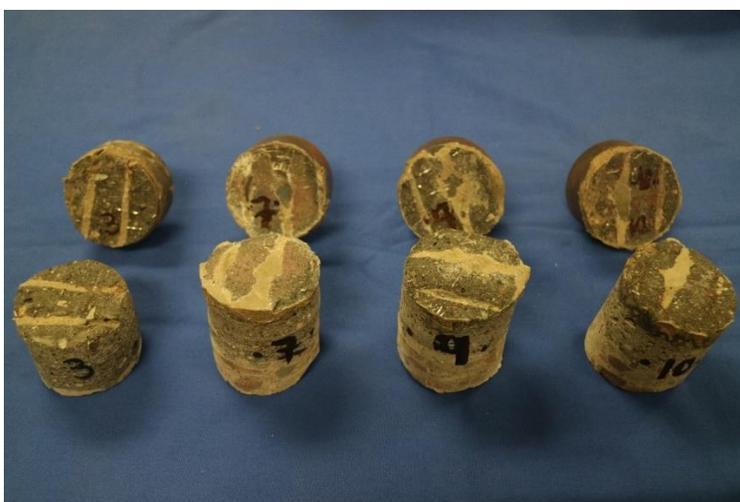
Figure 77. UHPC/epoxy failure.

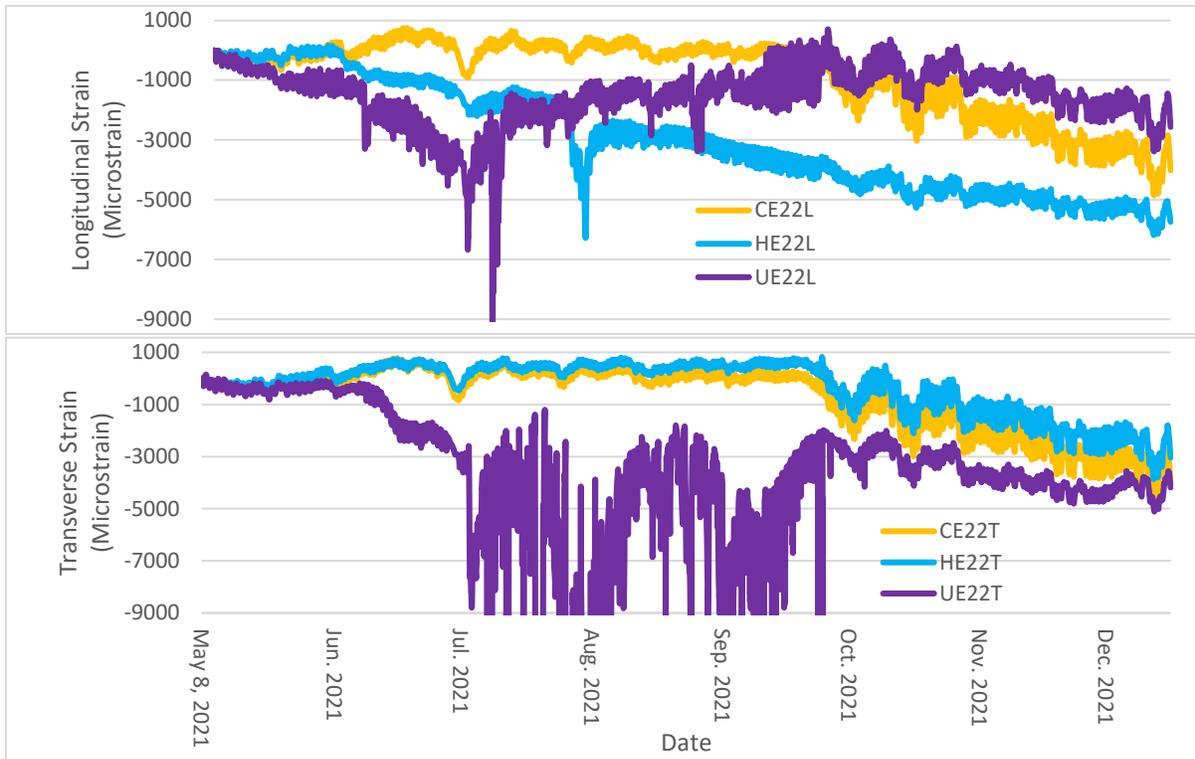
**Figure 110. Longer-term longitudinal and transverse strain in eastbound lane - bay 2 – position 2.**
