Field Retrofit and Testing of a Corroded Metal Culvert Using GFRP

Project No. 20STUNM30

Lead University: University of New Mexico

Final Report
March 2022

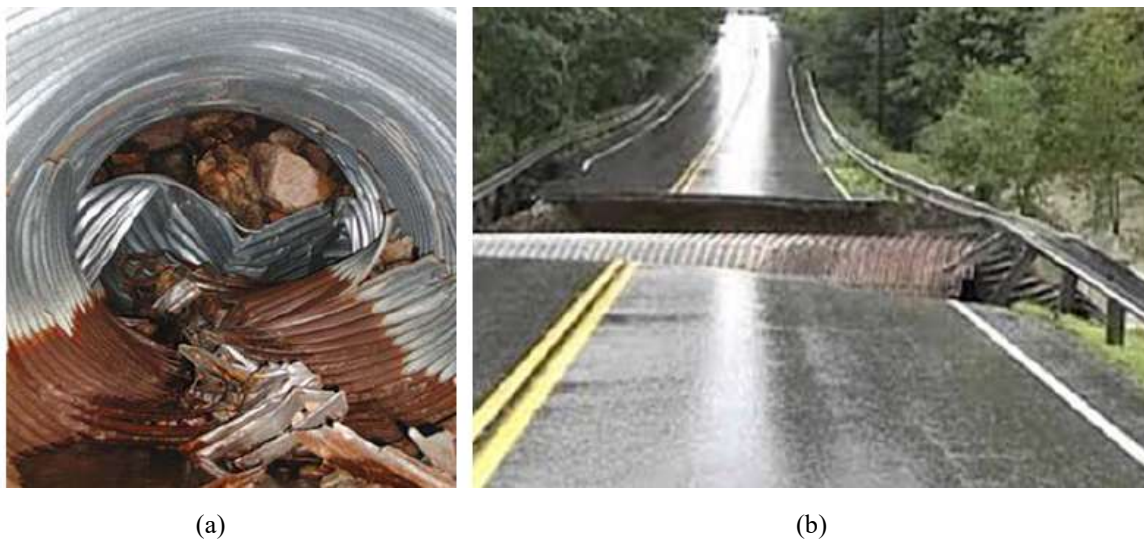
FIGURE 2 Failure of corroded metal culverts [2].

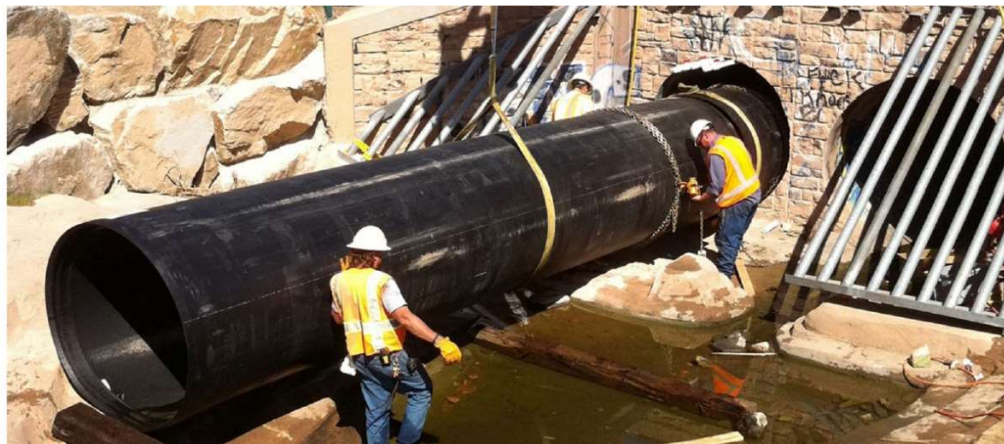
FIGURE 3 Culvert retrofit using HDPE pipes [2].

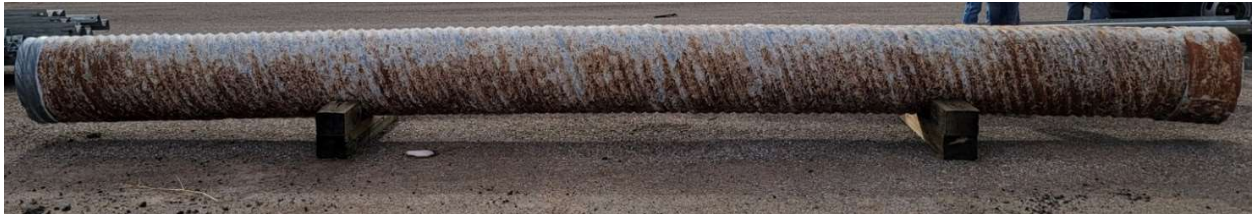
FIGURE 5 Corroded metal steel pipe

The design method was applied for future implementation on a steel CMP of 25 ft, shown in Figure 5. The steel pipe had a nominal diameter of 24 in, and an average corroded thickness of 0.05 in. The retrofitted pipe will be buried under 18 in of soil, with a slope of 0.001. A grout thickness of 1.5 inches was assumed, resulting in a GFRP outside diameter of 21 in. The culvert was provided by NMDOT in La Mesita Patrol Yard.

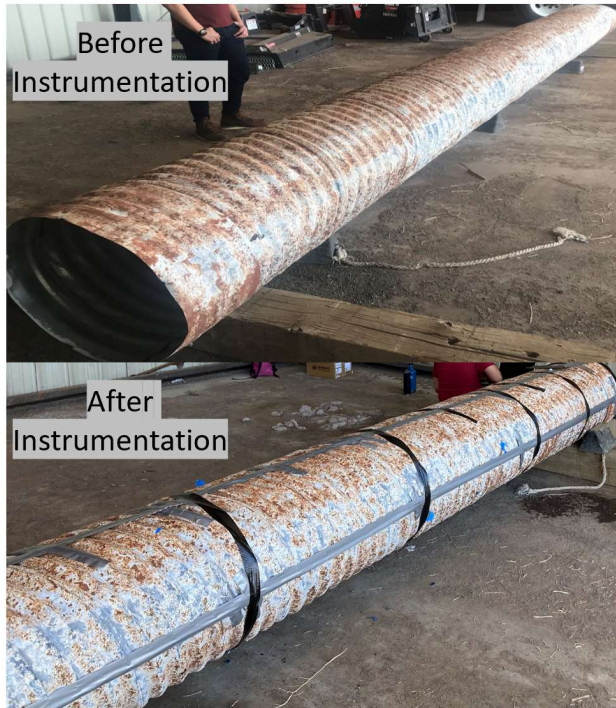
FIGURE 11 Corroded metal pipe before and after instrumentation

Upon arrival to the NMDOT La Masita Yard, the corroded metal culvert was moved to a shed to install the strain gauge sensors, as shown in Figures 11 and 12. The culvert pipe was cleaned from dust and rust and was ground at the planned sensor locations. The sensors were soldered on the cleaned surface. After all sensors were placed, the pipe was buried under 18 in of soil before load testing.

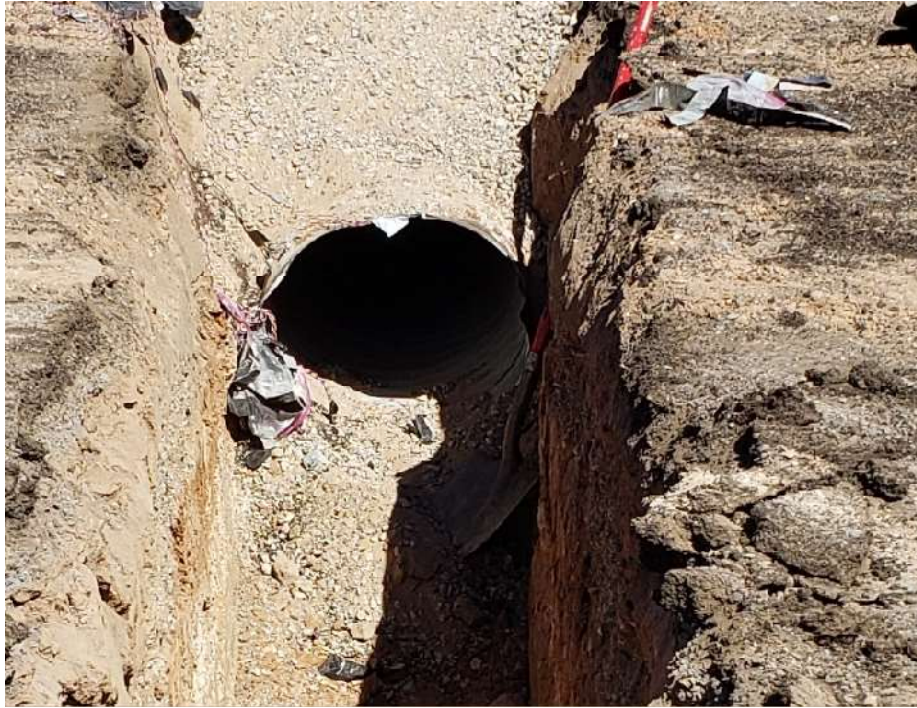
FIGURE 13 Buried corroded metal pipe

After the corroded corrugated metal pipe was buried at a depth of 18 inches, as shown in Figure 13, load testing was performed. Before testing, the truck was weighed on a weighing scale, as shown in Figures 14 and 15. First, an empty truck with a total weight of 25.75 kips traveled over the center of the culvert, with the wheels aligned with the exterior sensor arrays. The truck was then filled with sand, to a total weight of 48.55 kips, and traveled on the same path over the culvert. Finally, the loaded truck traveled near one of the ends of the culvert, with the interior wheels of the truck aligned with the exterior array of sensors. The breakdown of each wheel load is presented in Figure 16.

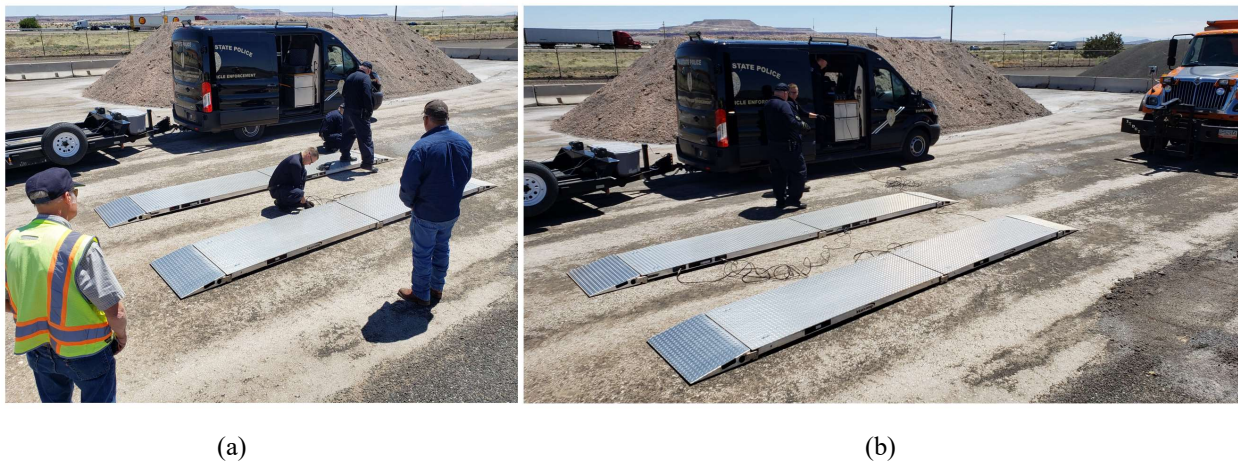
FIGURE 14 Weighing scale used to weight the test truck before and after filling it with sand. (a) scale installation. (b) scale after being wired.

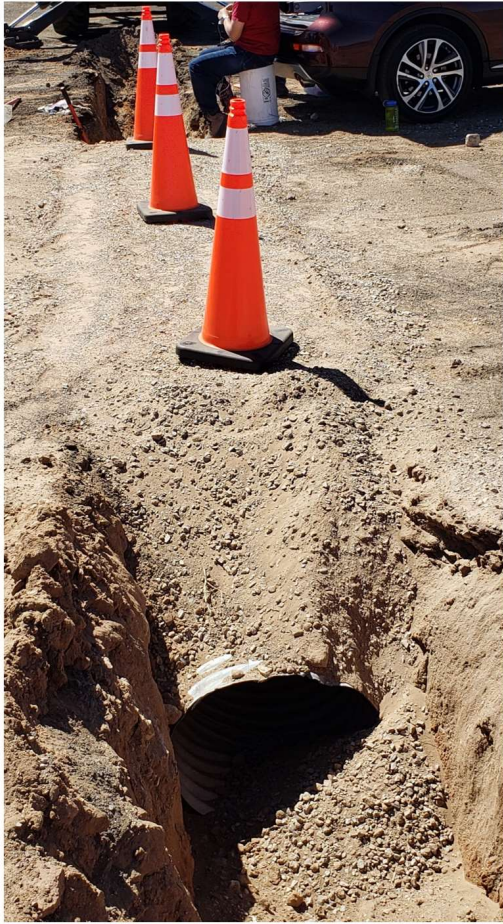
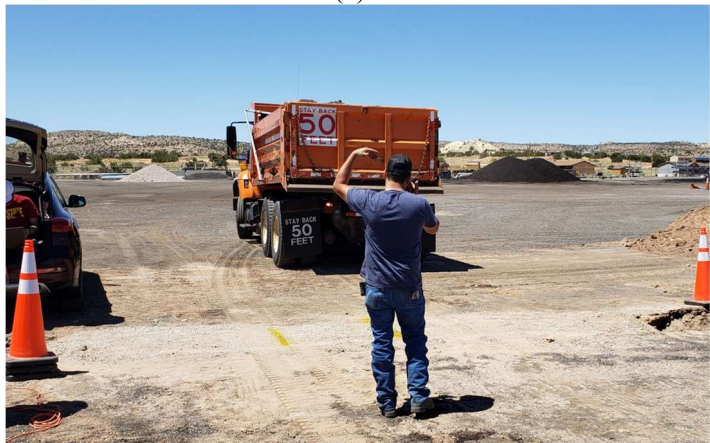
FIGURE 15 Corroded corrugated metal culvert buried (a), load testing (b) truck getting filled with sand, (c) truck passing over culvert.

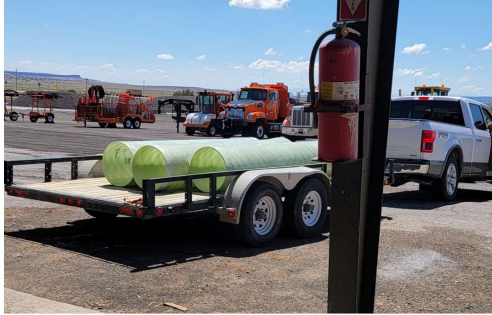
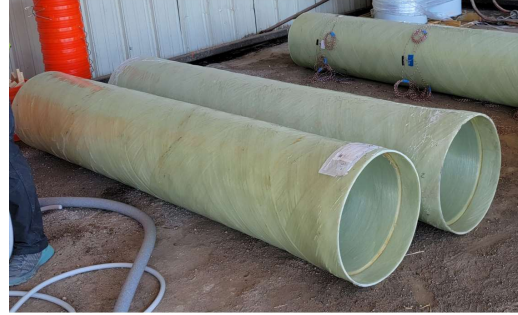
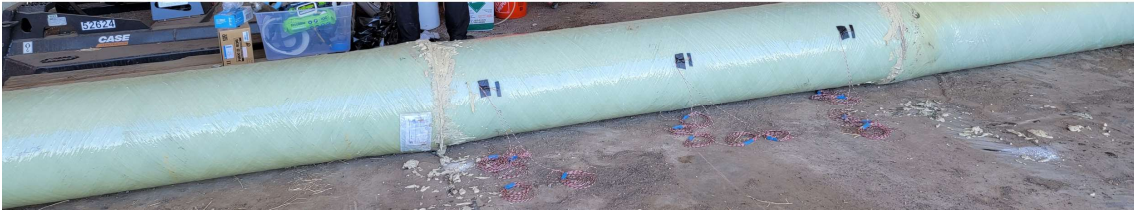
FIGURE 18 GFRP pipe (a)-(b): Transportation of 3 GFRP sections to NMDOT yard (c) instrumentation and connecting the GFRP pipe segments.

Upon arrival at the NMDOT yard, the GFRP pipe pieces were moved to a shed to install the joints using polymer composite compatible with the GFRP material. The pipe was left for 24 hours to cure. As shown in Figure 18, after the joints cured and hardened, the wires of all sensors were secured and extended to the ends of the GFRP pipe, before the GFRP pipe was transported with a forklift to be installed for the slip-lining process.

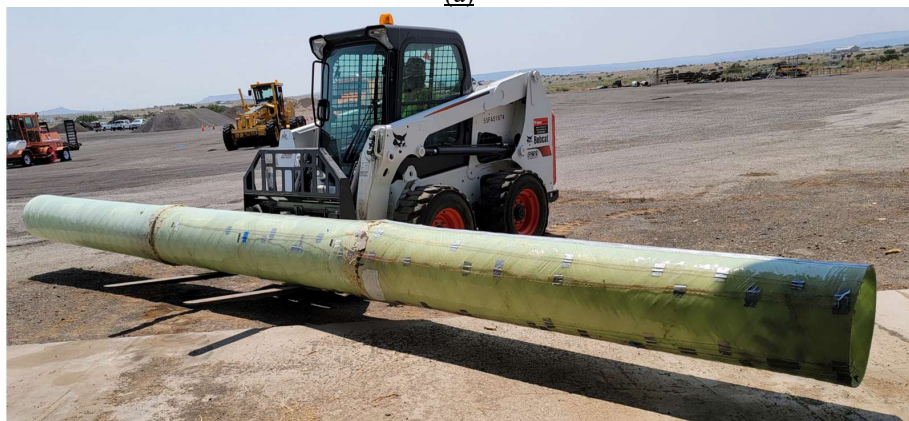
FIGURE 19 (a) Final instrumented and connected GFRP Pipe Before Slip-Lining. (b) Transporting integrated GFRP pipe to slip-lining location.

The instrumented and integrated GFRP pipe was transported using a forklift to the location of slip-lining, as shown in Figure 19. It was then carefully aligned and placed in an extended trench created ahead at the culvert front, such that it could be aligned with the buried corrugated metal pipe.

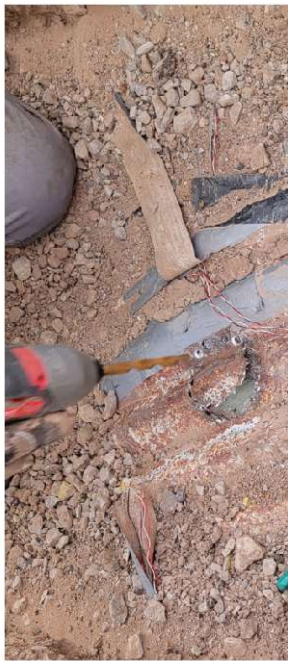
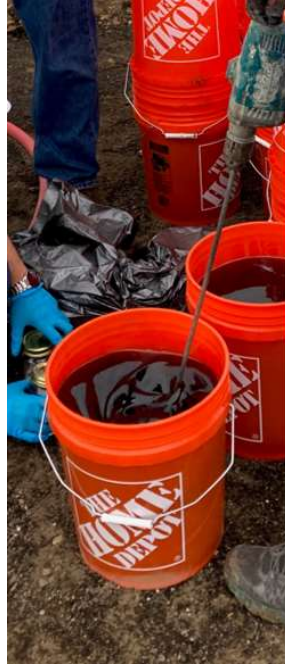
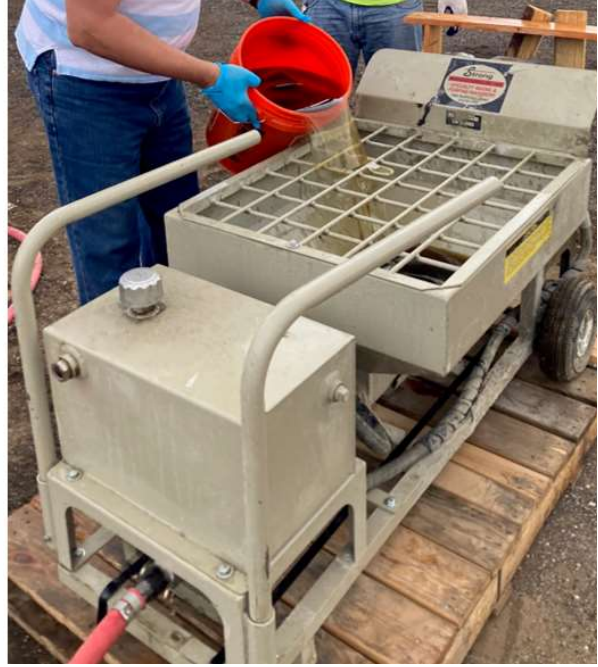
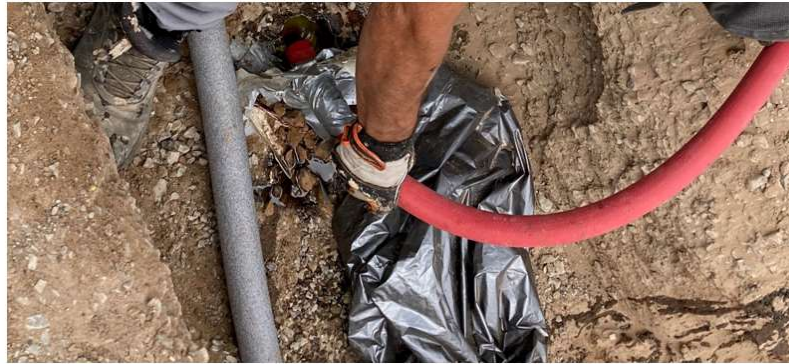
FIGURE 23 Mixing and pumping polymer in the annular space using an opening at the middle of the span. (a) perforation to inject polymer. (b) polymer mixing. (c) polymer pumping. (d) polymer injection.

Typically, fine aggregate is mixed with the polymer to reduce shrinkage of the grout. Due to the relatively small annular space, it was decided to grout the annular space between the GFRP pipe and the corrugated metal pipe using the polymer only. The polyester-based polymer was mixed and injected using a grout pump, as shown in Figure 22. Pumping was initiated at an opening created at the top of the metal pipe at mid span and continued until the polymer overflowed from both ends of the culvert. Overflow was allowed to take place for a few minutes to ensure all the annular space was filled with the polymer. Thin rods were inserted in the annular space at different heights and ensured all the annular space was filled with the polymer.
